Leveraging digital elevation models for data-driven assessment of evolutionary damage in built heritage

Manlio Montuori^{1*}.

^{1*} – Department of Architecture, University of Ferrara, Italy, manlio.montuori@unife.it

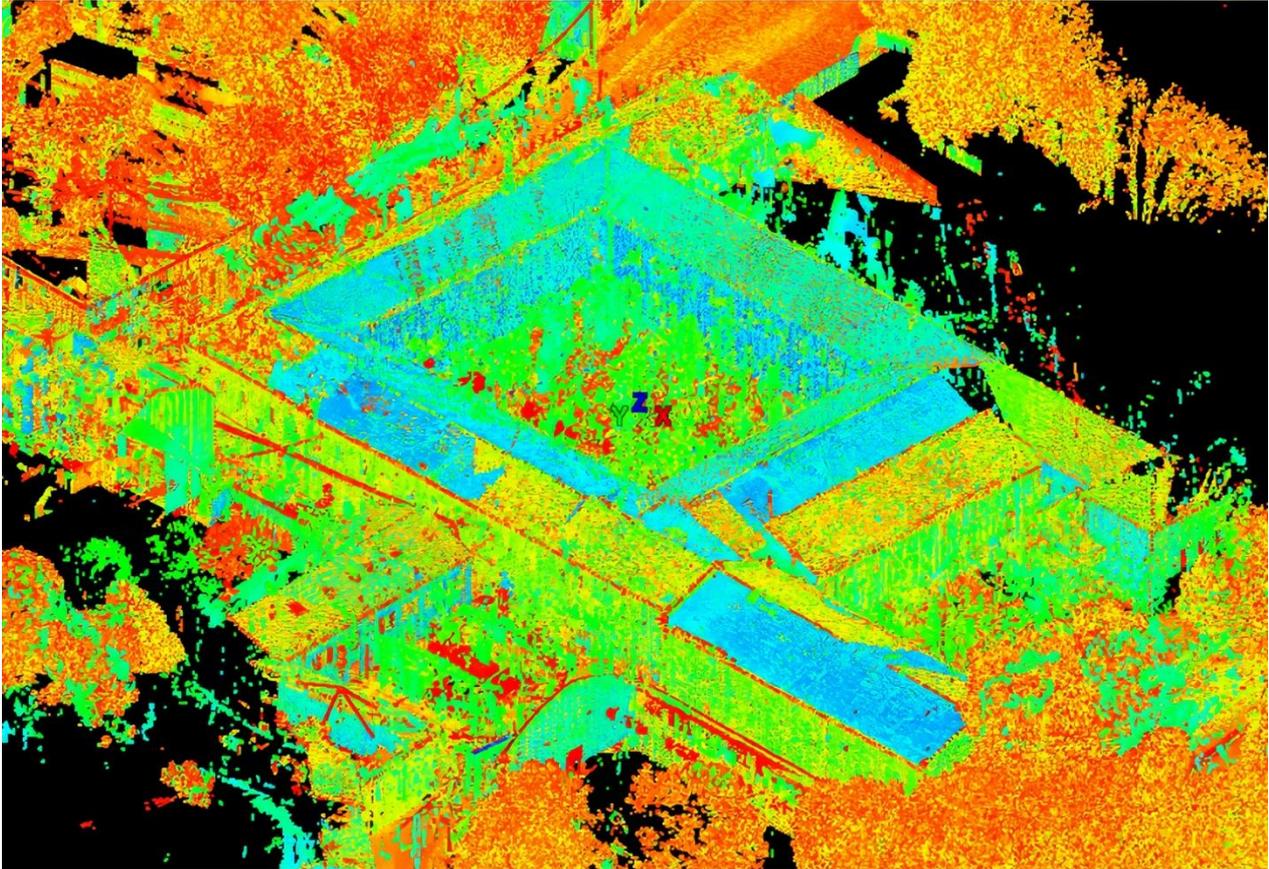
99
100 Figure 2. Perspective view of the registered 3D point cloud processed in Leica Cyclone r2020.1®, registered within
101 a single coordinate system centered on the cloister.

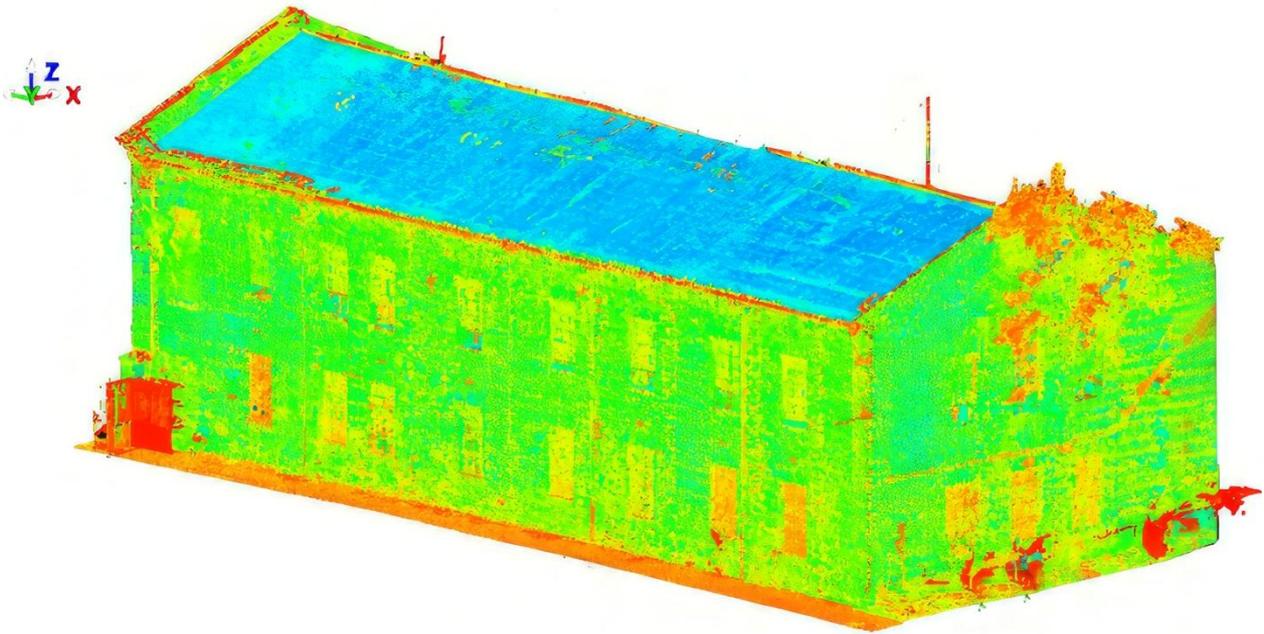
Figure 3. A detailed axonometric view of the TLS point cloud processed in Leica Cyclone r2020.1® True Space mode, showcasing the former church of St. Catherine.

90 The continuous advancement of technologies such as terrestrial laser scanners (TLSs) and unmanned aerial systems
91 (UASs) has significantly facilitated data acquisition processes. The Leica P40 TLS survey campaign was carried out in
92 two phases: planning and acquisition. More than 200 laser scanner station points were pre-estimated. In situ scans were
93 optimised by room size and complexity. Acquired data were processed in Leica Cyclone r2020.1®, aligned with <4
94 mm tolerance, and exported after registration into a unified 3D point cloud database. A single three-dimensional
95 coordinate system was then established, with the origin point (Fig. 2) located at the centre of the cloister. The point
96 cloud was subsequently decimated and exported in .pts format. To support this operation, due to the large file size and
97 processing demands, the building was divided into four segments: the west wing, the east wing, the south wing, and

98 the former church (Fig. 3).

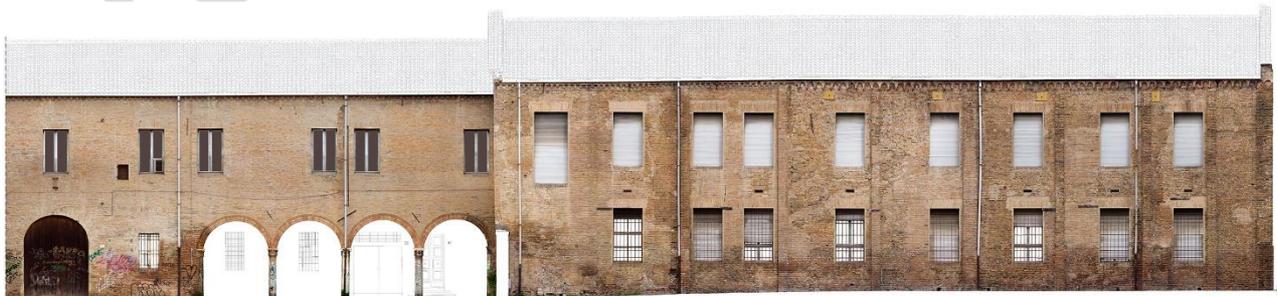
Figure 4. The orthomosaic of the south-facing elevation along Via Roversella, generated in Agisoft Metashape Professional r2.0.10®. On the right, the eastern wing reveals substantial structural transformations of the former church's liturgical hall, resulting from its 20th-century conversion into a vocational high school.

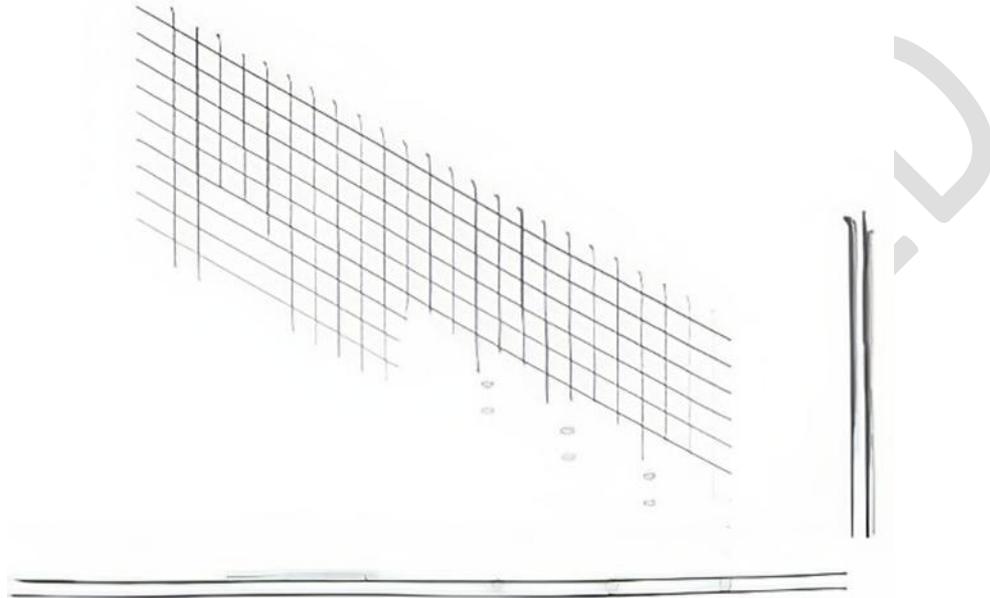
198
199 Figure 5. Front elevation along via Roversella, TLS-derived horizontal and vertical slices extracted at 1 m pitch and
200 assembled as a modular grid/wireframe for preliminary screening of out-of-plane rotation; the inset overlay against ideal
201 axes suggests.

This approach proved especially significant for the analysis of macroelement kinematics within the broader conservation project. The front elevation was analysed by projecting it onto an ideal reference plane. This surface was defined as perfectly orthogonal and aligned through the midpoint of the masonry thickness, allowing a normalised reading of the façade. The method revealed multiple phases of transformation, namely the opening of new windows, the closure of others, and the insertion of intermediate floors associated with changes in use, which were graphically represented and subsequently interrogated from a structural standpoint. In particular, a zone of high concern was identified where an incipient out-of-plane rotation appears to localise, plausibly activated by the thrust transmitted by the roof struts (Fig. 5). The evidence from TLS point cloud processing, including systematic slices at 1 m pitch, supports this interpretation and indicates areas of potential concern. To support this preliminary kinematic interpretation, the TLS point cloud was processed through a systematic sequence of horizontal and vertical slices extracted at a constant 1 m pitch, thereby generating a modular grid and the corresponding wireframe representation of the façade. This slicing-based modelling enabled a first-order verification of geometric continuity between the interior and exterior faces,

190 providing evidence compatible with predominantly monolithic behaviour within the wall plane and, conversely, not
191 supporting the presence of non-integrated facing leaves whose differential deformation could promote peak-load-
192 induced local instability. Although the deformation is not readily appreciable along the longitudinal development of
193 the slender masonry walls, the bottom-right overlay of the extracted slices against ideal horizontal and vertical reference
194 lines documents, albeit in a barely perceptible manner, the onset of the rotation mechanism. A more explicit and
195 metrically controlled representation of this phenomenon is provided later in the paper through DEM-based processing,
196 which allows the deformation field to be visualised and quantified with higher sensitivity. The point of most significant
197 structural instability corresponds to two distinct stratigraphic units.

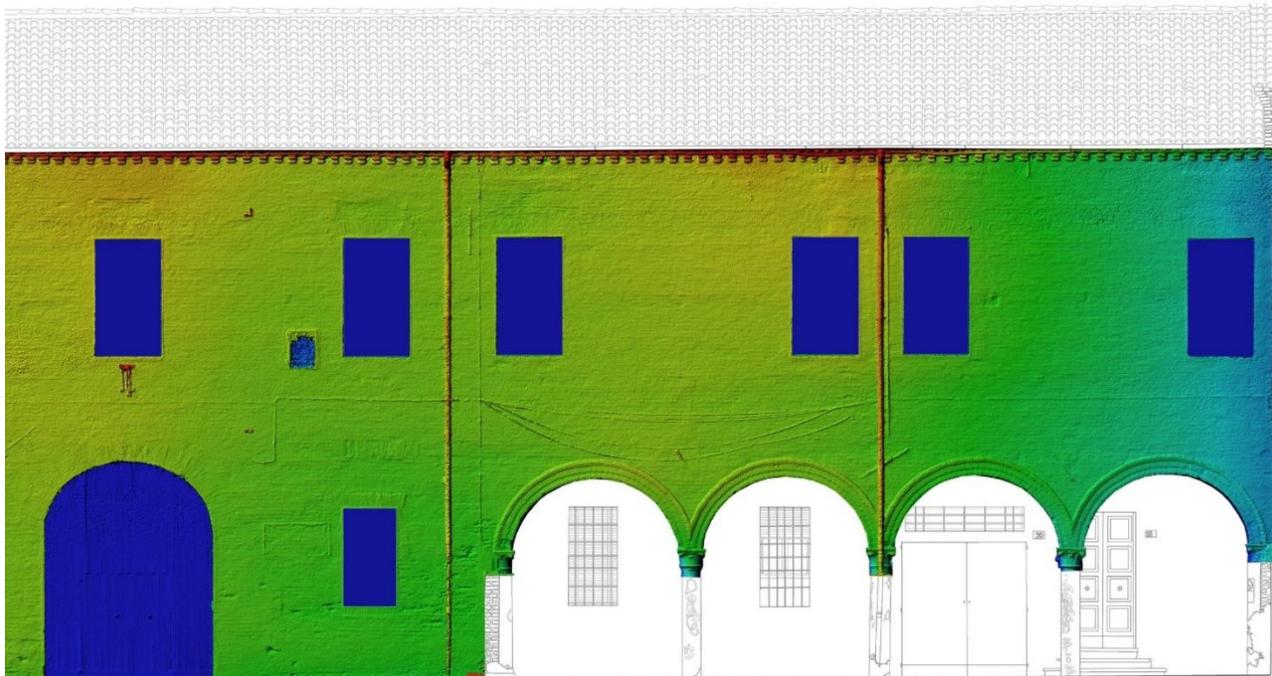
Figure 6. Front elevation along via Roversella, digital elevation mode processed in Leica Cyclone r2020.1®. The false-colour DEM highlights deformation patterns that are not detectable through direct visual inspection. In particular, at the junction between the gutter pipe and the right-hand downpipe, the red hue representative of the wall surface indicates a strain distribution consistent with the activation of an out-of-plane overturning mechanism. This condition has then been attributed to the deterioration of the timber truss bearing support, which has led to a structural transition from isostatic to thrusting behaviour.

220 To support the identification of the most appropriate safety interventions, the contribution of DEMs in the
221 evolutionary damage analysis of macroelements is highlighted here. One particularly hazardous behaviour observed is
222 the horizontal flexural deformation of the brick wall, as clearly illustrated by the DEM. In this condition, the masonry
223 wall is joined to perpendicular walls, but its top edge is unrestrained. When subjected to seismic action orthogonal to
224 its plane, the wall exhibits a horizontal arching effect (Fig. 6). Specifically, the horizontal thrust from the roof is

225 transferred to the wall. At the orthogonal intersections, this thrust splits into two components: one orthogonal to the
226 wall, which is absorbed by the tie rods of the roof trusses; and one parallel to the wall itself. In the limit equilibrium
227 condition, three hinges typically form, one near the centre of the wall and two at the intersections with the truss ends,
228 where tensile stresses are highest.

229 The three-hinged isostatic arch becomes unstable when its hinges align. If the wall fails to engage contrasting
230 elements that provide an equal and opposite reaction, the collapse kinematics will be activated. This is the precise
231 condition found in the case under analysis. The wall is held by tie rods but is stressed by the anomalous pushing action
232 of a strut and by the hammering forces of the large roof framing elements. Moreover, the tensile strength of the masonry
233 is reduced, increasing the risk that the material forming the wall's outer face may detach. This detachment is caused by
234 tensile stresses that develop within the masonry core as part of the kinematic deformation. Additional factors contribute
235 to the onset of horizontal bending mechanisms. These include the presence of aligned openings just beneath the roof
236 band and the quality of the masonry itself, which affects the height of the detachment wedge.

237 The identification of horizontal bending mechanisms is significantly supported by the DEM, which provides
238 essential information on existing and potentially active macroelements, even in cases where visible damage is minimal.
239 When cracking is not yet present, potential out-of-plane collapse mechanisms may still develop, involving varying
240 extents of the wall surface [23]. However, it remains impossible to determine in advance which kinematic mechanism

257 In the specific case of the via Roversella façade, the methodology implemented integrates laser scanning, computer
258 science, Geographic Information System (GIS), and particularly BIM as its foundational components [28]. The false-
259 colour rendering of the elevation data, mapped onto orthogonal projection planes, revealed a subtle yet coherent
260 horizontal flexure extending across the upper third of the masonry surface. This deformation, although imperceptible
261 through traditional surveying techniques, is consistent with the hypothesis of an evolving macroelemental mechanism
262 involving horizontal bending and rotation around the truss anchorage zones. The localised strain concentrations,
263 represented in red and yellow hues in the DEM visualisation, coincide with zones of structural discontinuity historically
264 associated with spatial transitions within the *endonartece* hall, such as the demarcation between the cloistered and lay

265 areas. This correlation confirms the DEM's capacity to interpret architectural transformations as potential precursors
266 to mechanical instability. The chronological stratification of the façade, reconstructed through archival analysis and
267 architectural interpretation, provided a more nuanced understanding of its structural behaviour. The area exhibiting the
268 highest deformation was also the segment most affected by 20th-century interventions, including the insertion of
269 reinforced concrete floors and alterations to the original roofing system. These modifications induced eccentric load
270 distributions and altered the thrust paths transmitted by the timber trusses, thereby amplifying the flexural demands on
271 the slender masonry panels. The DEM, in this context, became a medium through which these hidden effects could be
272 quantified and localised with high precision. Notably, the DEM allowed for the anticipation of collapse kinematics by

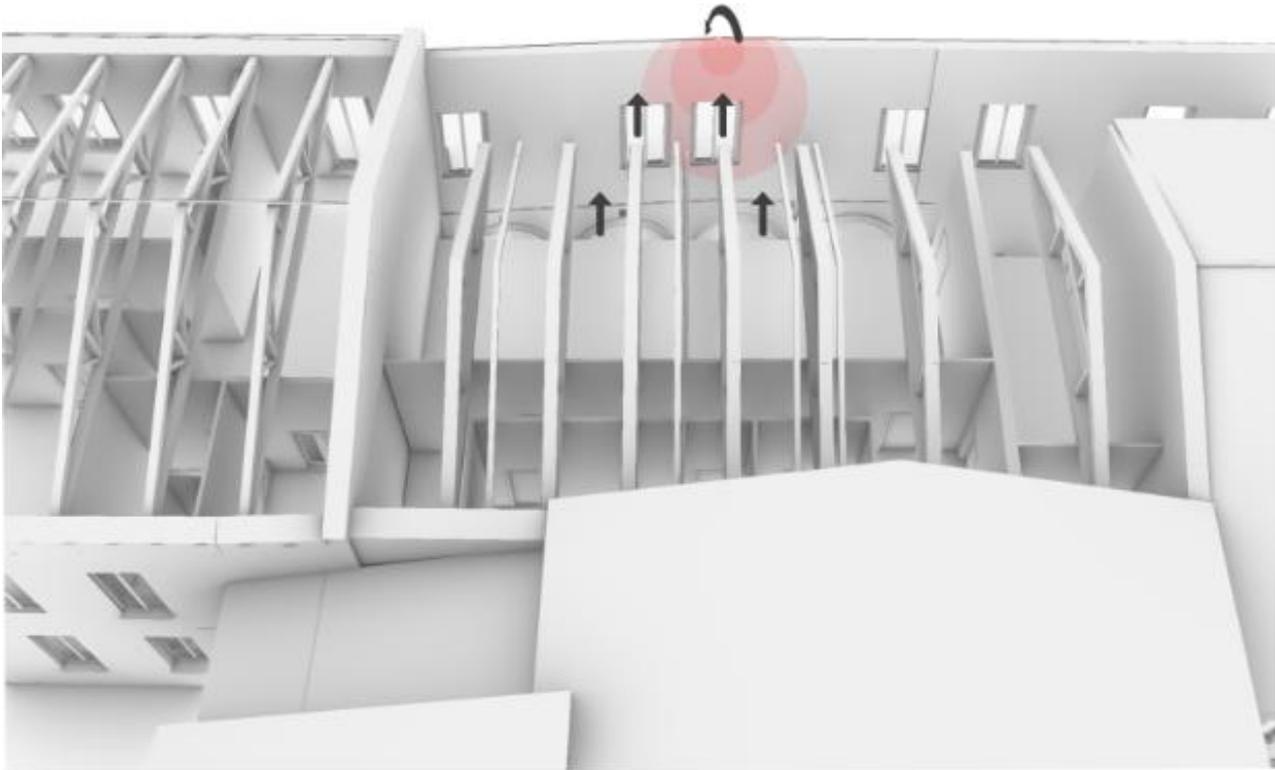
Figure 7. Former church of St. Catherine, south elevation, macroelement collapse mechanism. The representative three-dimensional model of the collapse mechanism is developed using Graphisoft Archicad 27®, providing a more straightforward interpretation of the triggering cause linked to the degradation of the roof queen-post timber truss system lying behind the masonry wall.

273 identifying deformation modes before the complete crack pattern associated with the masonry's settling response
274 manifested. This pre-diagnostic function is particularly significant in heritage contexts, where preventive conservation
275 strategies often need to operate in the absence of overt structural symptoms. The identification of stress trajectories and
276 micro-deformational anomalies supports a predictive understanding of macroelement behaviour, particularly when
277 integrated with knowledge of mechanical discontinuities, construction techniques, and load-bearing hierarchies. In this
278 regard, the study demonstrated that the DEM could simulate an intermediate condition between the as-is configuration
279 and the limit equilibrium state, effectively capturing a transitional phase in the structural lifecycle. This capability is
280 especially relevant for walls exhibiting three-hinged arch behaviour, where the incipient collapse mode is governed by

281 the alignment of hinges and the degeneration of in-plane restraints. The current case study revealed that the pushing
282 action of the roof queen-post timber truss system, compounded by the absence of adequate counter-thrust mechanisms
283 in the longitudinal direction, promoted a partial and localised overturning mechanism in the affected masonry (Fig. 7).
284 The DEM detected this deformation as a differentiated surface deflection, offering a direct false-colour visualisation of
285 the deformation gradient along the affected wall surface.
