# Documentation and Visions for the Reuse of Abandoned Historical Heritage. The Case of Alianello in Basilicata, Italy

**Abstract.** The research involves different disciplines concerned with the study, knowledge, and monitoring of heritage from landscape, geological, urban, structural, and architectural points of view, aiming to propose design hypotheses and visions for a new use and regeneration of fragile heritage rendered fragile by natural disasters. The case study examined is the historical center of Alianello, a small municipality in the Lucania region in the province of Matera, consisting of a medieval village that is now completely abandoned and whose buildings are in a state of physical and structural decay that could be easily resolved if recognized and consolidated with awareness and critical knowledge through documentation integrated by technical knowledge. The study was articulated by subdividing the urban fabric into 47 building aggregates, the overall damage conditions of which were analyzed, caused by various geomorphologic and seismic disruptions that led to the abandonment of the built-up area, but did not make the structures completely uninhabitable, for which

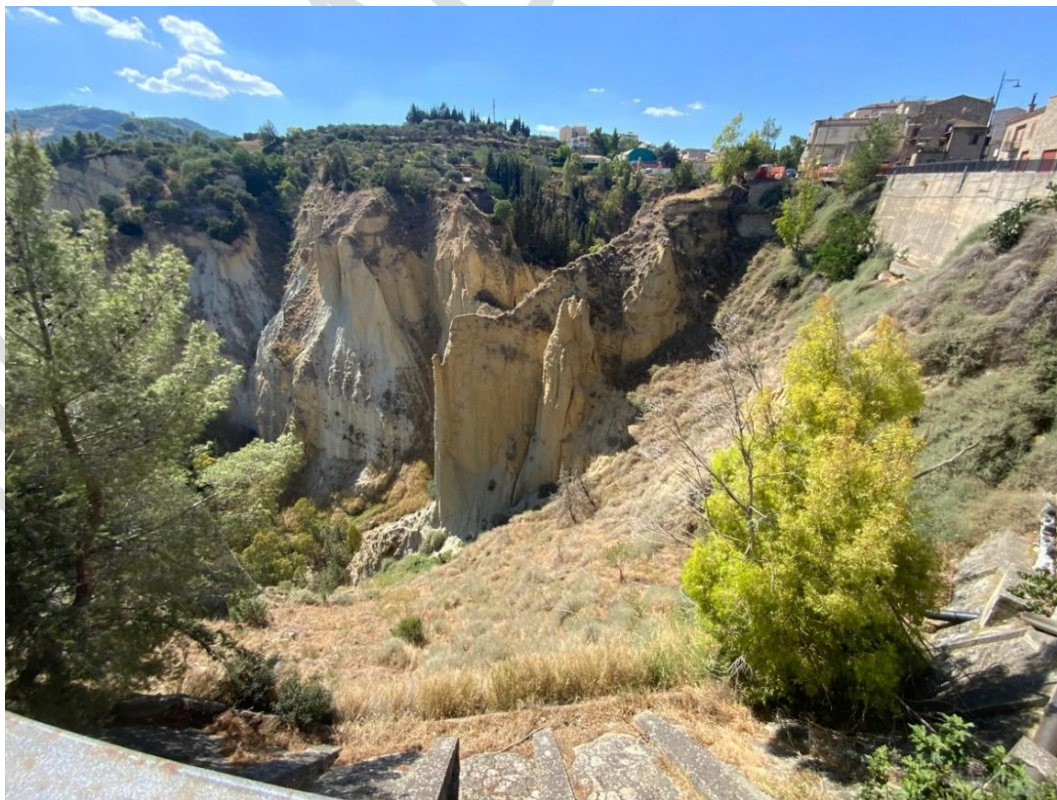
Figure 2 – Aliano (MT). View of the city overlooking the “calanchi” ravine. © 2024, Authors.

100 on its south-eastern border, where the houses overlook a steep slope. This slope exhibits vertical fractures that  
101 separate rock blocks, which periodically detach and fall to the base of the slope onto a landslide deposit.  
102

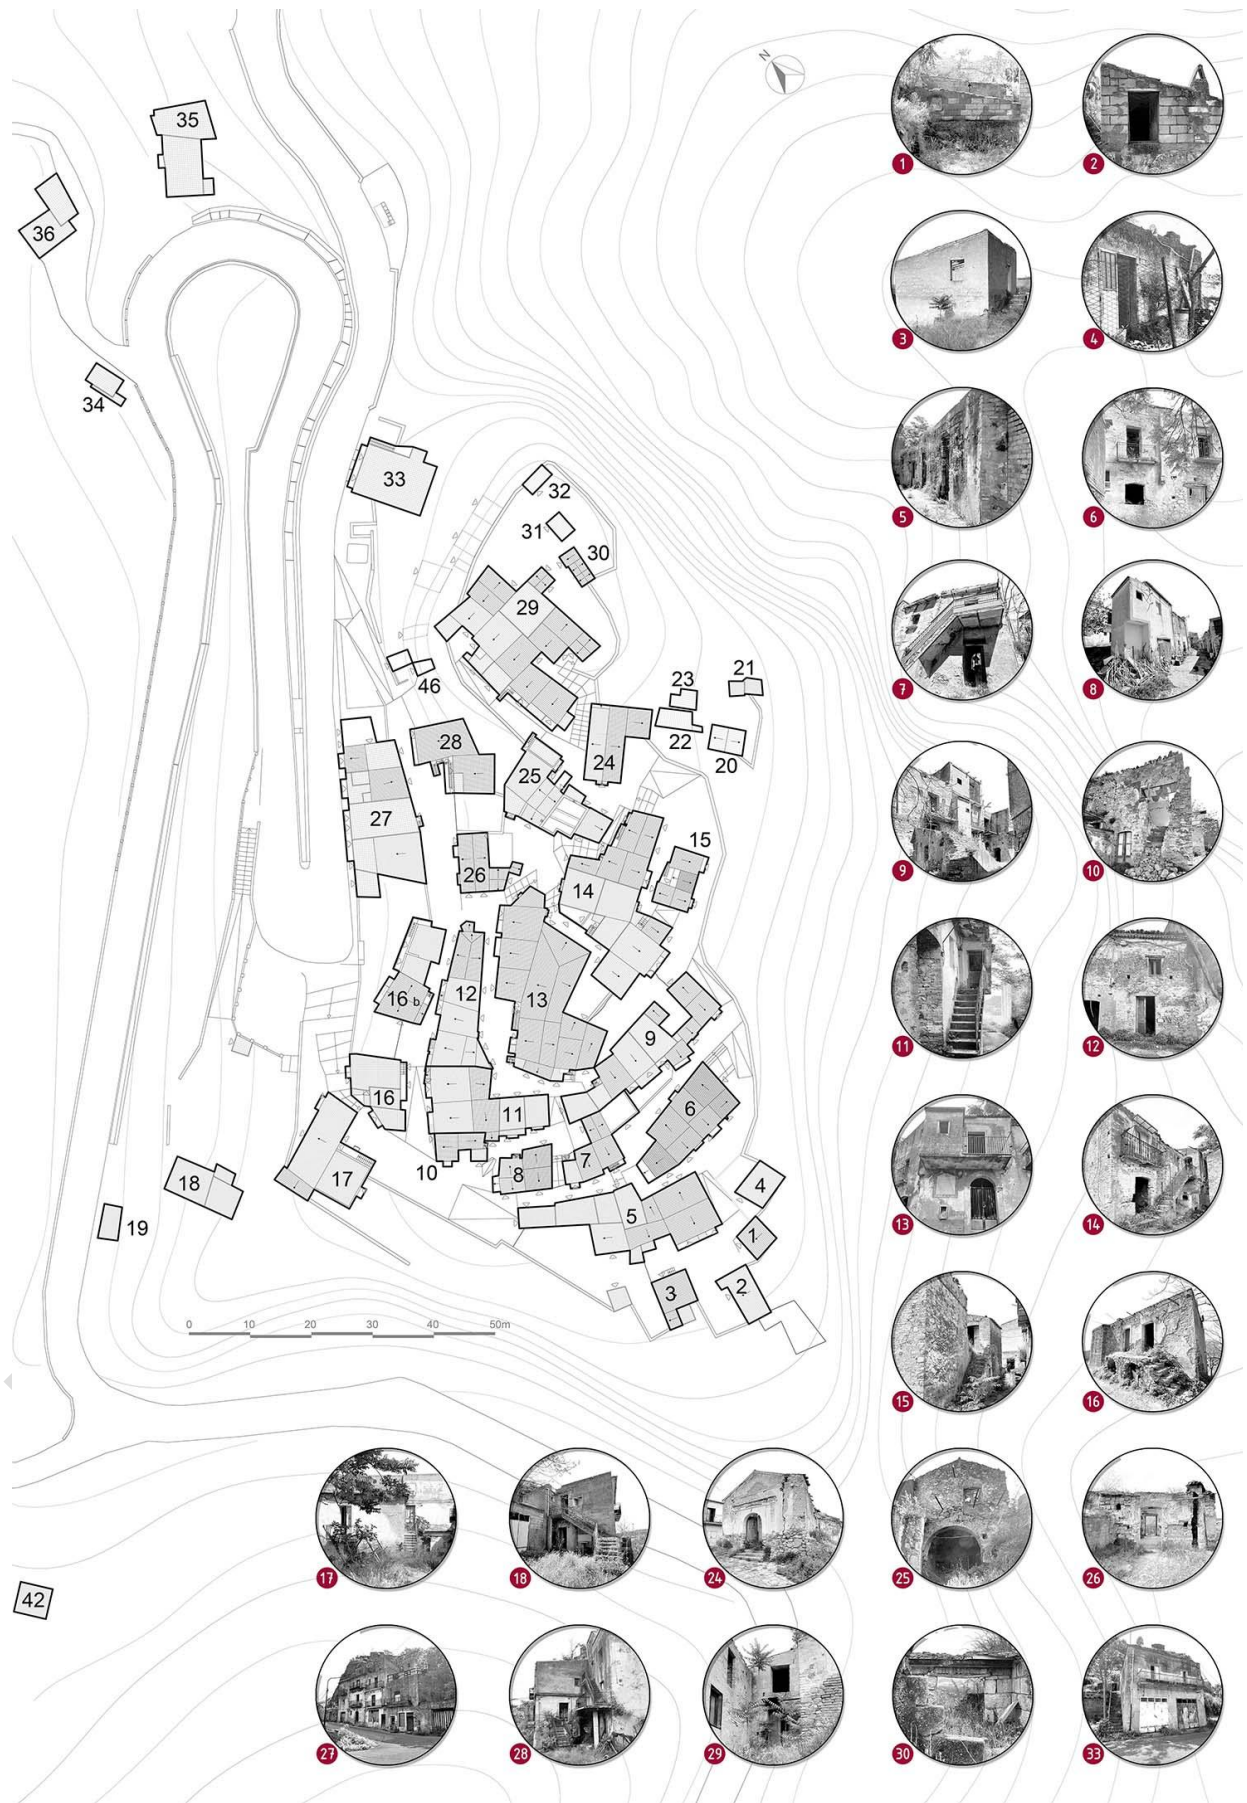
Figure 4 – The 47 blocks of “Alianello Vecchio”. © 2024, Authors.

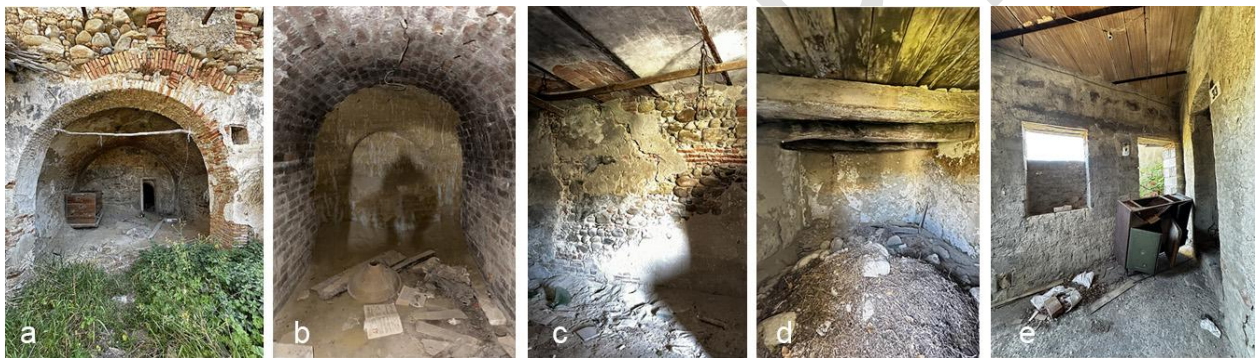
Figure 6 – a: brick barrel vault building 25b ground floor. b: brick barrel vault building 25a cellar ground floor. c: floor with beams and vaults (beams with deformable slab) building 25a ground floor. d: wooden floor with simple framework planking (beams with deformable slab) building 25d ground floor. e: floor with beams and large planks (beams with semi-rigid slab) building 25a first floor. © 2024, Authors.

- 164 • the vaulted horizons of the basement and ground floor of “Building 25b” (Figure 6a) and the  
165 ground floor of “Building 25a” (Figure 6b) from all others that are flat structures with  
166 deformable or semi-deformable slabs. The vaults on the ground floor of buildings 25a and 25b  
167 are without chains, and the structures are already pushing under the action of vertical loads  
168 alone. This push may increase due to seismic action that could lead to the collapse out of plane  
169 of the walls if there were no counter-thrust from the two adjacent buildings;

- 170 • the floor consisting of beams with deformable slab of the 25a all-storey and 25d first floor  
171 (Figure 6c);
- 172 • the horizontal components of “Building 25c” (now collapsed) and 25d on the ground floor  
173 (Figure 6d) are made of timber and double frames (beams and rafters) with simple wooden  
174 planking, with lapilli or rubble slabs. There is probably stiffening by means of double planking  
175 or a slab connected to the beams. The deformability and/or low resistance of this type means  
176 that, even if they are well connected to the vertical structure (a condition that was not found in  
177 any of the floors analyzed), they are not capable of constituting a constraint on the walls  
178 stressed out of plane, nor of redistributing the seismic forces between the walls stressed in  
179 plane. It may therefore happen that these horizons stress the walls out of plane, facilitating

180 collapse.
- 181 • The floor slab of the ground floor of the first room, rather recent extension, of “Building 25a”  
182 (Figure 6e) is a semi-rigid floor slab made of girders and flat soffit slabs with a shaved upper  
183 slab. The stiffness and strength of this floor, with a small span in the case of “Building 25a”, if  
184 well connected to the vertical structure by means of a kerb and diffuse seams, are capable of  
185 constituting sufficiently rigid constraints on the walls stressed out of plane and redistributing  
186 the seismic forces between the walls parallel to the direction of action, which enclose the floor  
187 field. These floors, on the other hand, are not sufficiently rigid to cause a redistribution of  
188 seismic forces between all the walls of the building.

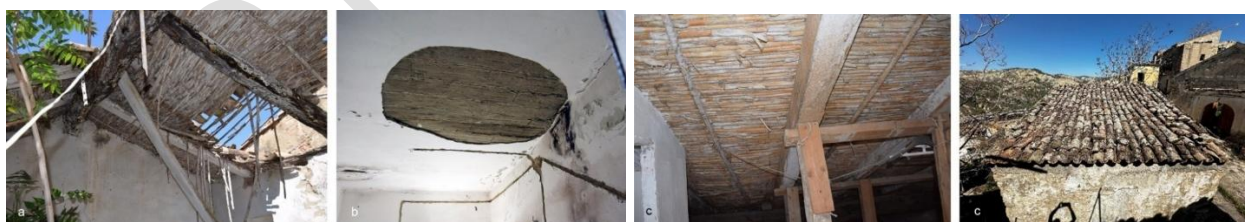
Figure 7 – a: roofing of building 25b beams, reeds, and tiles. b: roofing of building 25a, 2nd floor room under expansion. c: roofing of building 25a beams, reeds, and tiles. © 2024, Authors.

200 In all cases, with the exception of only the second-floor compartment of “Building 25a”, it is a pushing  
201 roof (Figure 7), since it lacks kerbstones and chains, but is light since it consists of timber and reeds  
202 in addition to tiles. The dangers are essentially related to the aggravation of the horizontal thrusts on  
203 the supporting walls due to the seismic forces; the condition would be favorable if the roof structure  
204 had sufficient rigidity and strength in its plane, so as to also play a positive role in terms of improving  
205 the overall box-like performance of the masonry. The roofing of the second-floor room in “Building  
206 25a” is of the heavy pushing type, although small in span. This is undoubtedly a serious condition, as  
207 the high mass causes the emergence of considerable seismic forces, while the pushing effect favors the  
208 out-of-plane collapse of the walls below. Other structural characteristics concern the possible presence

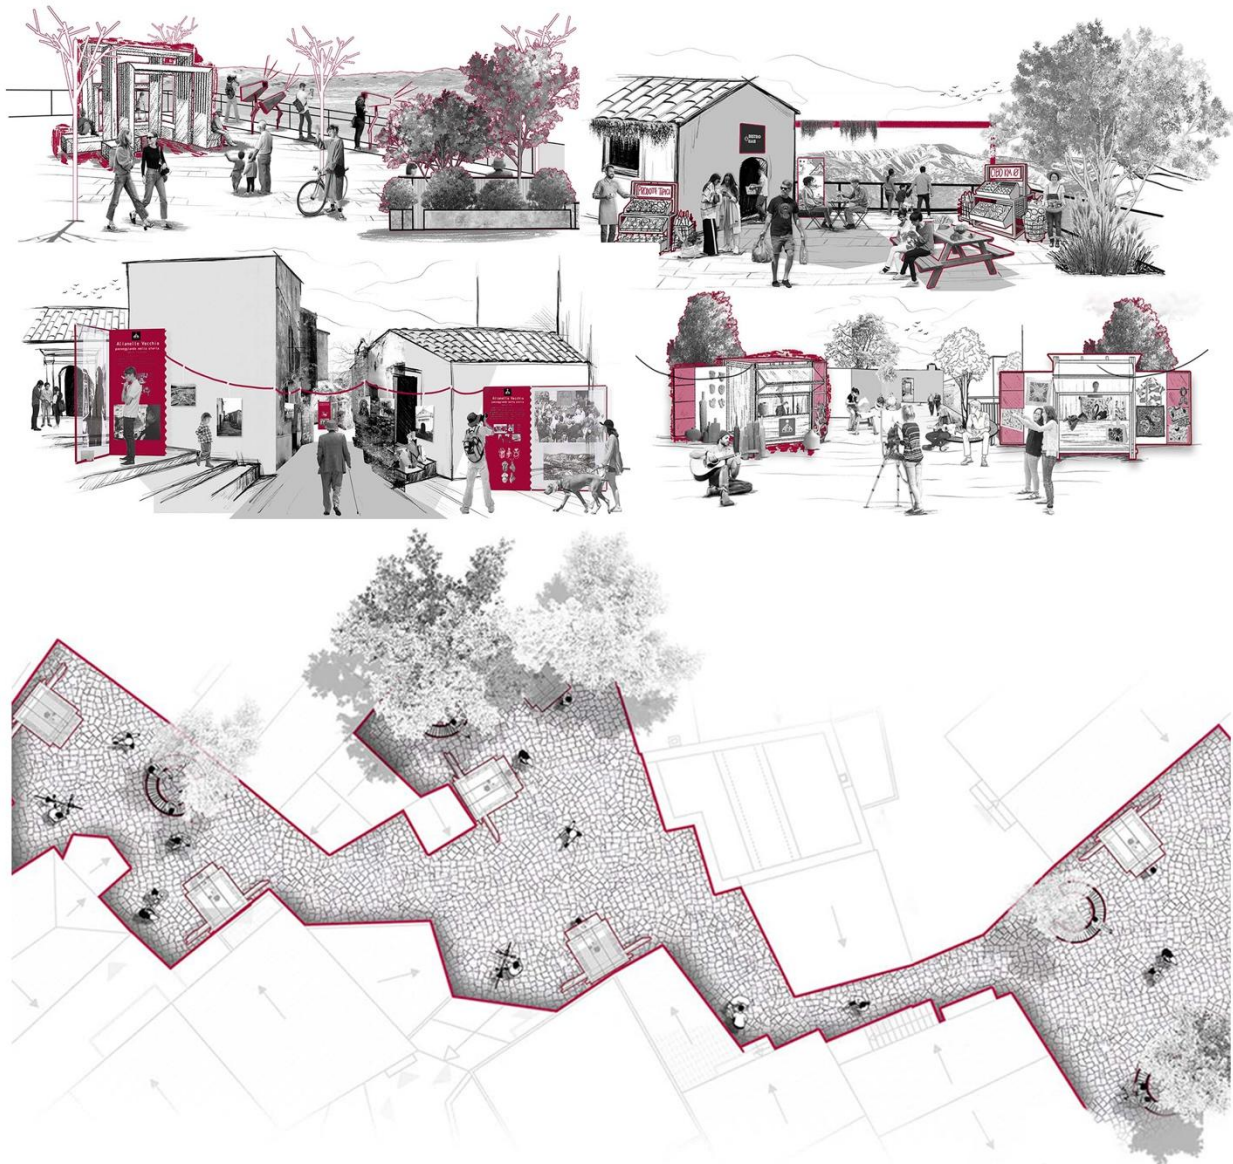
Figure 10 – Project hypotheses for the regeneration of the open public spaces in the city center. Views and plan. © 2024, Authors.
